Investigation of Solar Collector Fire Incident

**INVESTIGATION OF SOLAR COLLECTOR
FIRE INCIDENT**

William D. Walton

August 1981

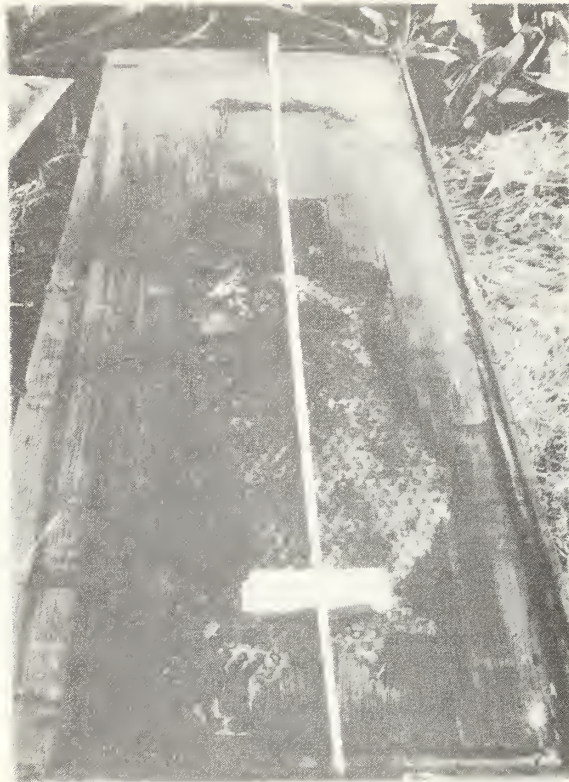
At no time did the firefighters observe open flaming, but there was considerable smoke in the ceiling area. The fire damage was limited to a single collector (number 4 on lot 33), the roof, and one joist space directly below the collector. After extinguishment, the absorber plate of the collector could be seen by looking through the hole in the ceiling from inside the house. Figures 9 and 10 show the collector involved in the fire after it had been removed from the house. In figure 9 the view is of the back of the collector with what is believed to be the upper end of the collector as it was mounted, at the bottom of the picture. Figure 10 shows the same collector with the plywood back turned over so

Figure 9. Collector involved in the fire - view of plywood back

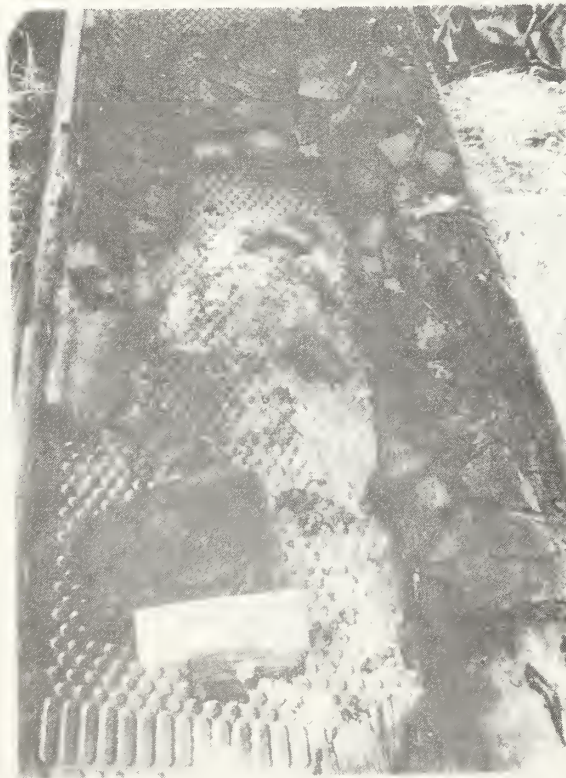
While it appears to be unlikely there are potentially several other materials in which self heating could have occurred within the collector assembly. Polyurethane foam has been known to self heat especially when freshly made and stacked in large piles [7]. There is very little information available on the temperatures at which rigid polyurethane foam degrades when heated for extended periods of time. This is due in part to the fact that its composition and properties vary widely. The evidence in this case indicates that the polyurethane was not providing substantial heat since the foam in the collectors not involved in the fire were blackened from the absorber side and the plywood blackened only when directly exposed to the absorber or when the foam layer was very thin. The urethane foam may have contributed to the fire when ignited by the glowing plywood. The fact that a considerable amount of the foam remained along the sides of the collector in which the fire originated as shown in figure 10 tends to support these conclusions.

Figure 10. Collector involved in the fire - view of interior side of plywood

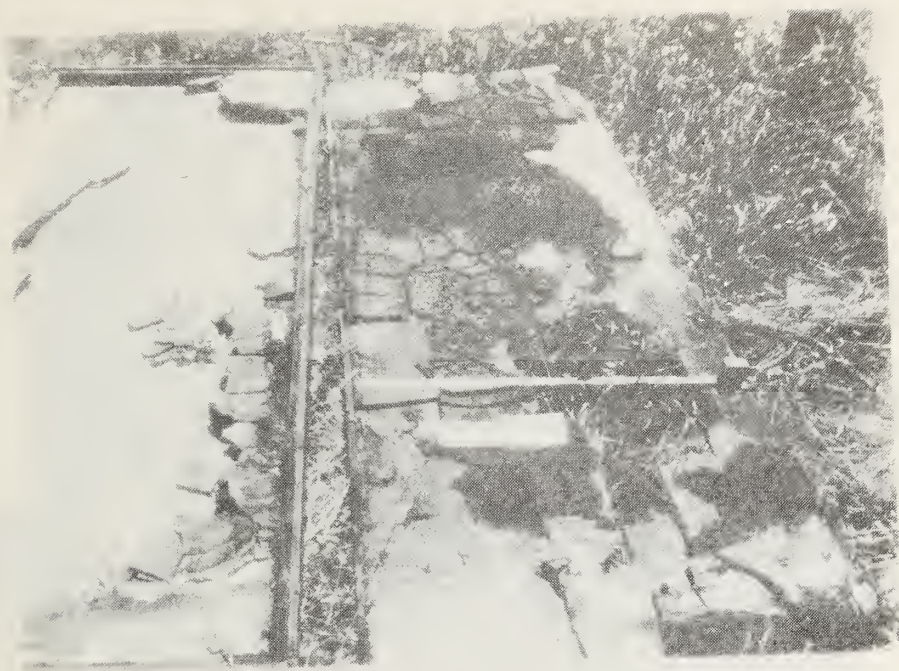
A few days after the fire the building contractor removed the collector involved in the fire and the two adjacent collectors in order to repair the roof. Collector number 3, which is shown in figure 11 with a hole in the back, was most likely not involved in the fire. The hole was created by one of the workmen when the collector was removed from the house. This collector shows substantial thermal degradation, apparently from solar heating. Collector number 5 showed only moderate degradation.

Figure 11. Collector 3, lot 33

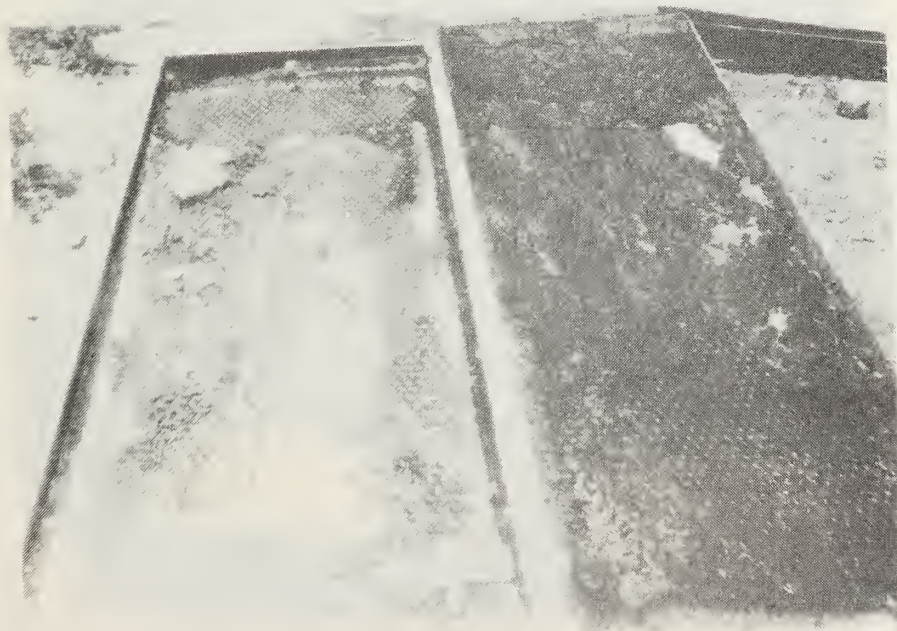
Examination of the collectors at the site revealed that in all the collectors the urethane foam had thermally degraded to some extent. Figure 12 shows a collector which is typical of those with the least amount of urethane foam degradation found at the site. In this picture, the plywood back with the foam attached is on the right and the remainder of the collector with absorber plate visible is on the left. The end of the collector which had been mounted towards the peak of the roof is at the top of the picture. It can be seen from the small piece of foam sitting on the upper left of the absorber plate that the blackening of the foam had not progressed through to the plywood. Although the foam had lost some of its original thickness and some cracking occurred, it remained substantially intact.

Figure 12. Collector typical of lesser degradation

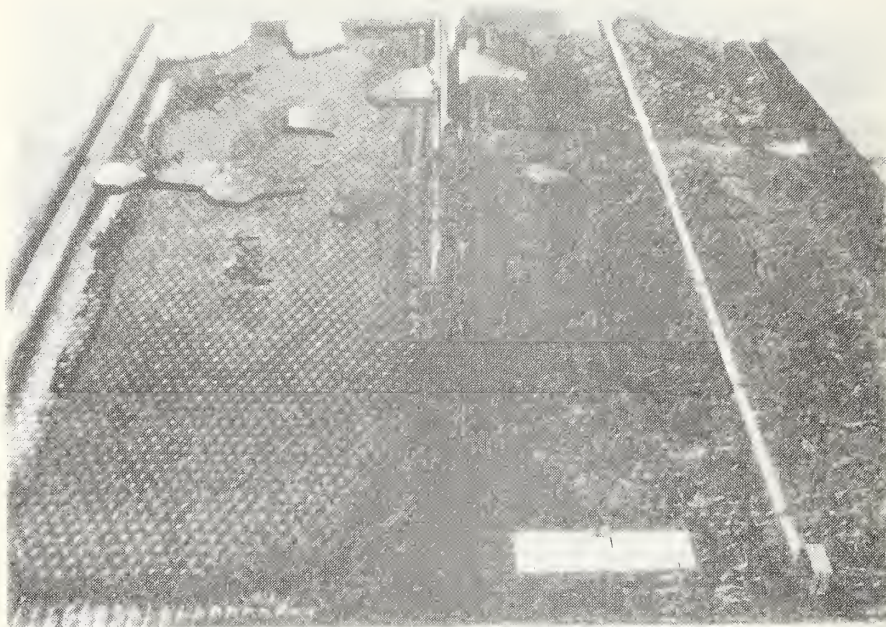
Figure 13 shows a collector which was typical of those at the site with more severe degradation. The collector in the photograph is in the same orientation as the collector in figure 12. In this case, the foam sitting on the absorber has darkened all the way through and some areas of the foam are at approximately one-half the original thickness. In addition, large cracks have formed throughout the foam layer. Close examination reveals a darkening of the inside of the plywood backing approximately 3 feet (0.9 m) down from the upper end of the collector.

Figure 13. Collector typical of more severe degradation

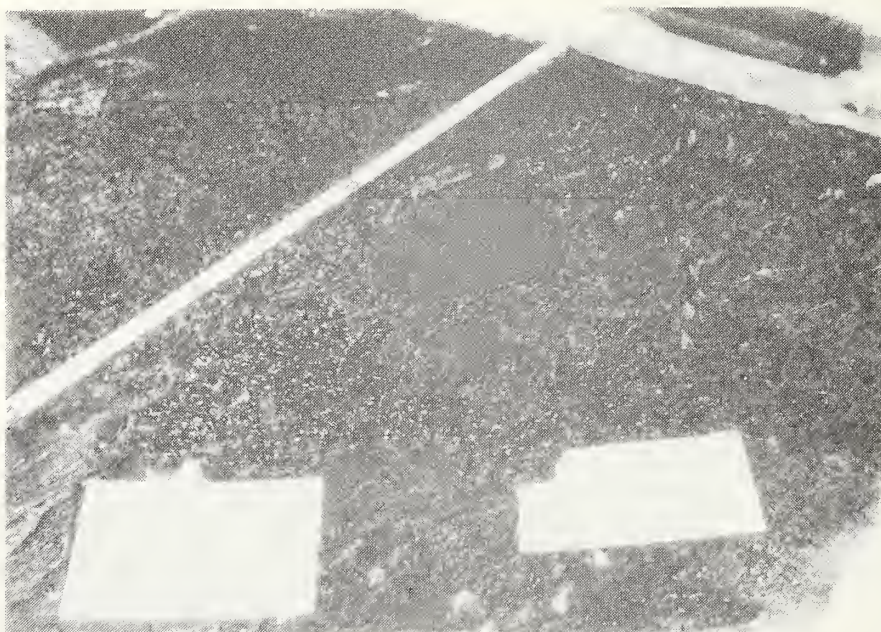
Figure 14 shows a close-up of the upper two feet (0.6 m) of the foam and plywood backing from the inside of a severely degraded collector. The urethane foam which remains has been reduced to a layer approximately 1/4 inch (0.6 cm) thick. The plywood backing has blackened considerably and begun to crack.

Figure 14. Close-up view of collector with severe degradation

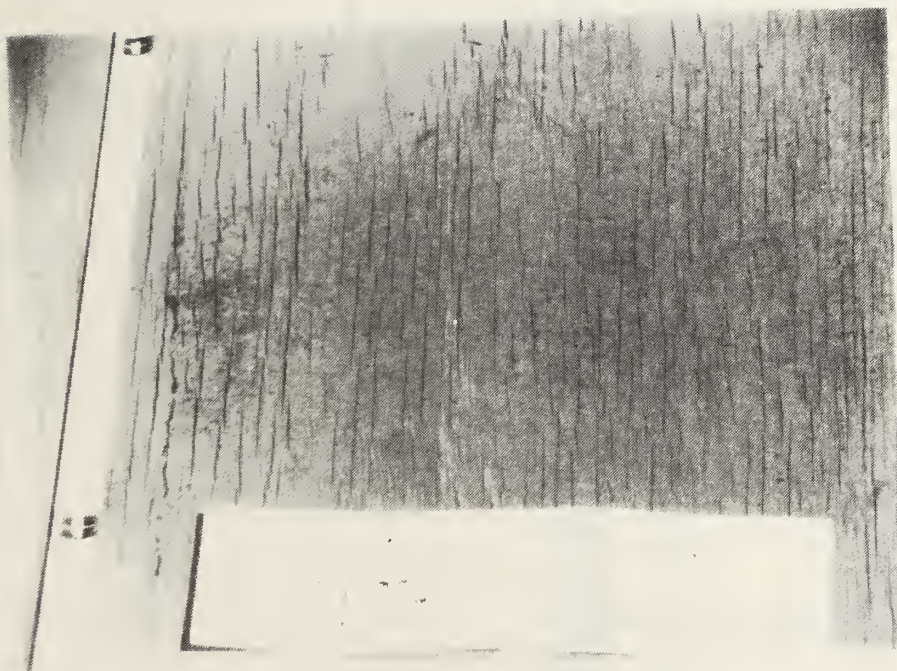
Severely degraded collectors also show degradation on the outside of the plywood backing. Figure 15 shows the back center of a collector between one and two feet from the end which was toward the roof peak when mounted. Cracking and a slight darkening of the wood is visible in this case.

Figure 15. Back of collector with severe degradation

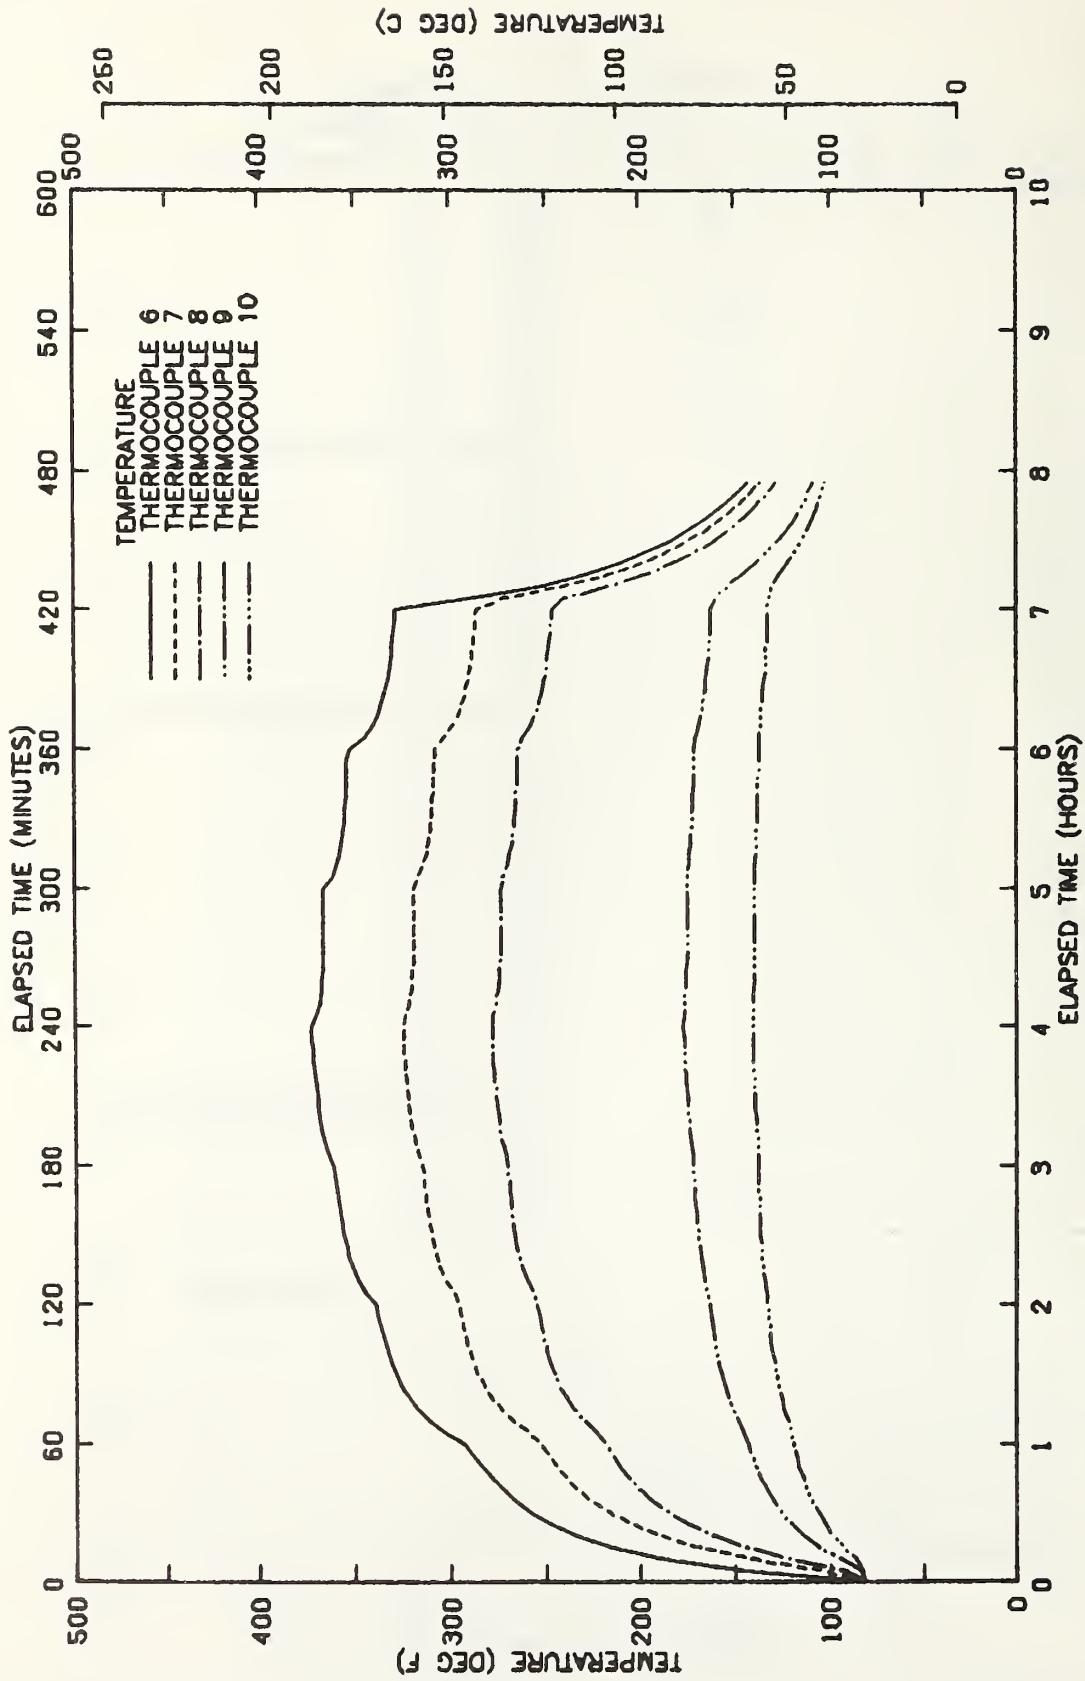
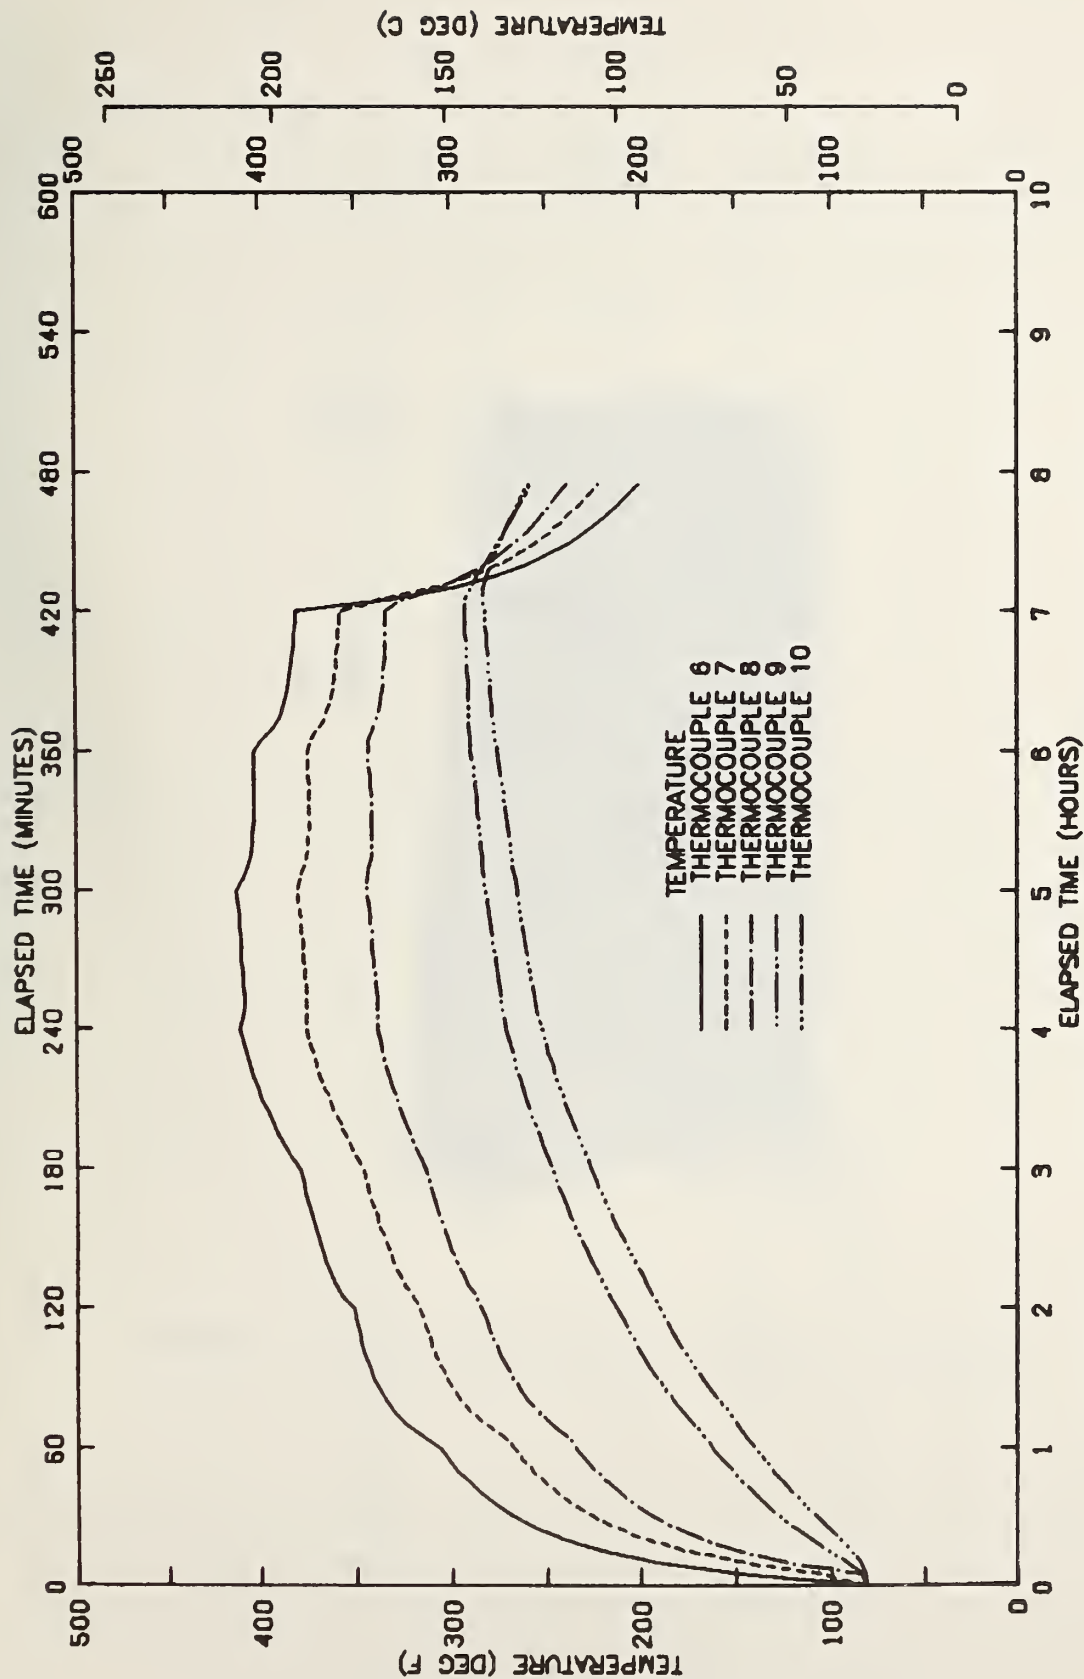
The test results show some variation in temperature between the three locations within the collector probably as a result of the condition of the insulation and the mounting of the thermocouples. The temperature profiles at the center of the collector are presented as typical of those at the three locations. Figure 18 shows temperature profiles for the collectors with no deck and figure 19 shows the profile for the collectors mounted over the simulated insulated roof deck.

The results show that the temperatures on the absorber plate and in the foam increased by approximately 40 deg F (22 deg C) in the collector mounted over the insulated roof deck. The greatest change was observed in the peak plywood temperatures which increased by over 115°F (64°C). For the collector with the back exposed to the air, the peak temperature at the plywood/foam interface was 177°F (81°C) and on the back side of the plywood the peak temperature was 141°F (61°C). In this case the plywood temperatures seemed to respond quickly to changes in the absorber plate temperature. The collector mounted over the simulated insulated roof deck had a peak temperature at the plywood/foam interface of 292°F (144°C) and 282°F (139°C) on the back side of the plywood. In addition, the temperatures did not reach equilibrium during the one hour periods of constant exposure but continued to rise until the exposure was terminated.

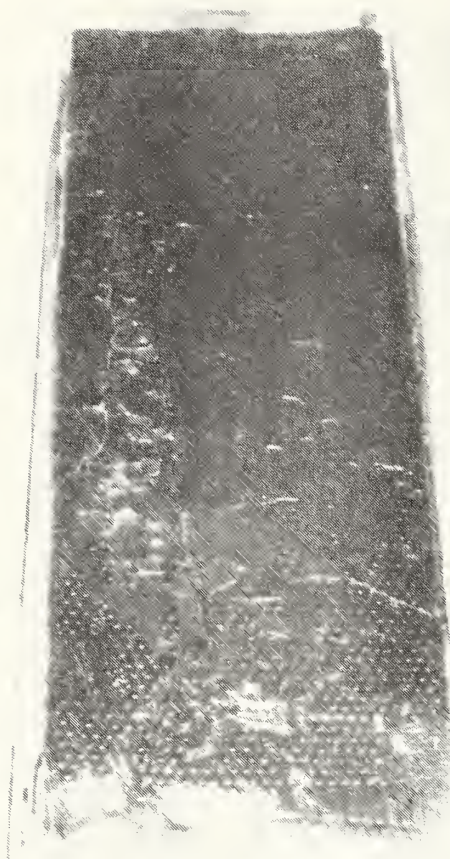
The results of the test conducted for DOE and similar tests conducted for the manufacturer show, within the accuracy of the measurement, no degradation of thermal performance at the end of 30 days. The collector in the DOE testing was later opened for inspection, which is not a normal part of the testing procedure. The foam insulation in this collector had degraded to a lesser extent, but in similar fashion to those from the site of the fire. Figure 20 shows the inside of the collector which was mounted on a test rack with the back exposed to the air during the tests. Figure 21 summarizes the conditions to which the collector was exposed. The minimum daily solar radiation required by the test procedure is $1500 \text{ BTU/ft}^2/\text{day}$ ($4725 \text{ Whr/m}^2/\text{day}$).

The results indicate that even though there is no measurable change in thermal performance of the collector over the 30-day stagnation test period, significant material degradation may actually be taking place.

Figure 20. Collector after 30-day stagnation exposure

- A. Consideration should be given to issuing a bulletin to the industry describing the potential fire hazard.
 - B. Collectors should be opened at the end of the 30-day stagnation test and examined for signs of material degradation. If combustible materials have degraded further testing should be conducted.
